This news bulletin is brought to your desktop by the UK Concrete Repair Association (CRA). It provides brief and easy-to-digest updates supplied by the CRA and its Members on recent concrete repair developments, new advances and other initiatives occurring in the industry.

CRA E-BULLETIN + CRA E-BULLETIN + CRA E-BULLETIN + CRA E-BULLETIN + CRA E-BULLETIN

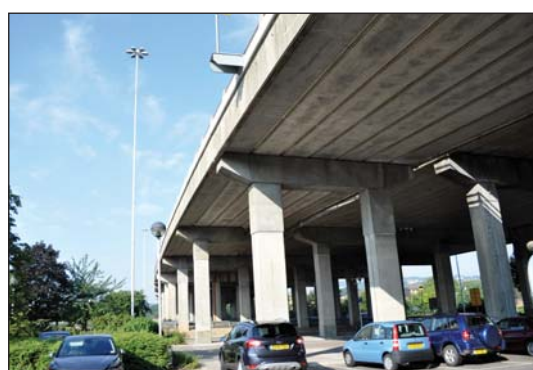
The A13 Pitsea Flyover serves as a major connecting route to the M25 from Southend. It spans a railway line, a local roundabout and a supermarket car park, but has suffered from corrosion problems caused mainly from leaking joints and the 'spreading' of de-icing salts during the winter months.

Various works have been carried out over the years and in November 2009 CRA contractor member, **Concrete Repairs Limited**, was awarded the contract for Phase 5 (by Essex County Council) to carry out major repairs to 15 cross-head beams and to install an impressed current cathodic protection (ICCP) system. The defective areas of concrete were broken out using hydro demolition and were reinstated with sprayed gunite. As with the previous phases of the works, it was decided that the cathodic protection system was to be 'mesh and overlay' consisting of a MMO coated titanium mesh with a sprayed concrete overlay.

To minimise the environmental impact of the works, CRL used noise attenuation boards fixed to the scaffold and the noise levels were regularly monitored. Essex CC was so pleased with the works undertaken, that they awarded CRL Phase 6 of the works (to repair a further 9 piers), which is currently underway.

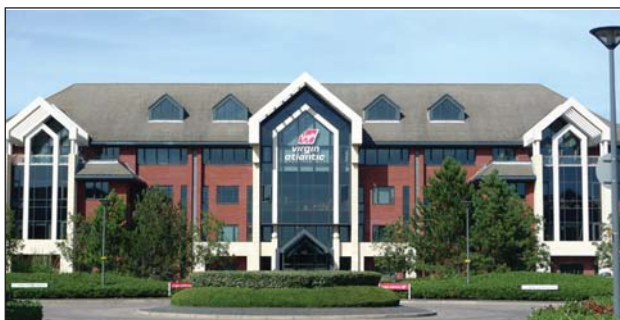
Concrete spalling, spotted on the 2-storey car park at the main Crawley office of Virgin Atlantic Airlines, prompted Virgin Property Portfolio Management to call in CRA contractor member, **Cemplas Waterproofing & Concrete Repairs Ltd.**

Cemplas found that the spalling was widespread across the car park and that the problem, if left untreated, could create a potential health and safety risk to Virgin employees, as well as posing the threat of damage to their vehicles.

Recognising that 'one size fits all' is not the correct approach to providing clients with the best service, Cemplas submitted a detailed survey report, together with a method statement and a lump sum cost to undertake the remedial repairs. As a result, all defective concrete was cut out, prepared and reinstated using Sika Rapid Repair Mortar.

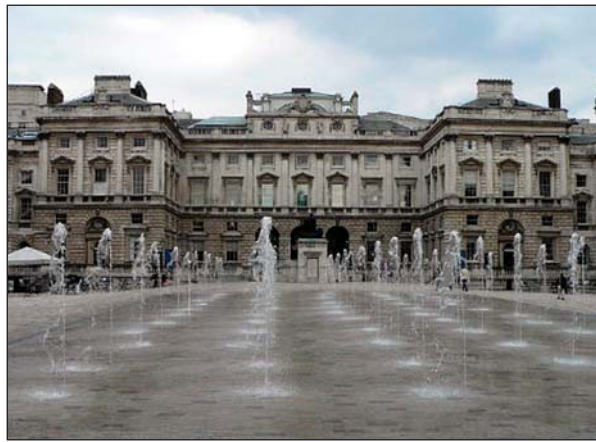
Due to movement, the 800mm thick external masonry walls of Somerset House, London's spectacular neo-classical 18th Century building, have been reinstated with stainless steel helical reinforcing bars by CRA contractor member, **Structural Renovations Ltd.**

In order not to adversely affect the building's external appearance of the building, the bars were resin fixed into drilled holes. In turn, the reinforcing bars were also bedded in slots cut into the perpendicular internal dividing walls, prior to making good and redecoration.

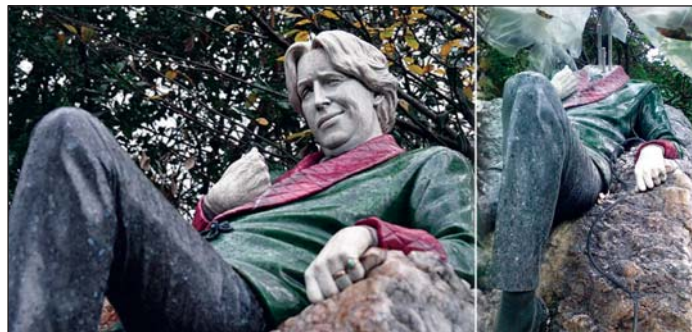
The statue, which was commissioned during the 1990s by the Guinness company and is situated in Merrion Square, across the road from the "Dail" (the Irish Parliament), required the new head after suffering from the rigours of the weather, wear and tear. It had been originally carved from various types of stone including Thulite, Jade and Granite, acquired from countries all over the world.

Parex' distributor had no hesitation in recommending Tecgrip CAS Cartridge and Thixotropic Joint Filler to restore the bond between the statue's body and its missing components after they had begun to crack. The hands were replaced at the same time.

The original sculptor, Danny Osborne, returned to replace the items (originally in porcelain) by new ones replicated in jade, which is a much harder material. These were bonded into place with the same high strength materials used on the original in 1997. The artist confirmed his satisfaction with the Parex products.

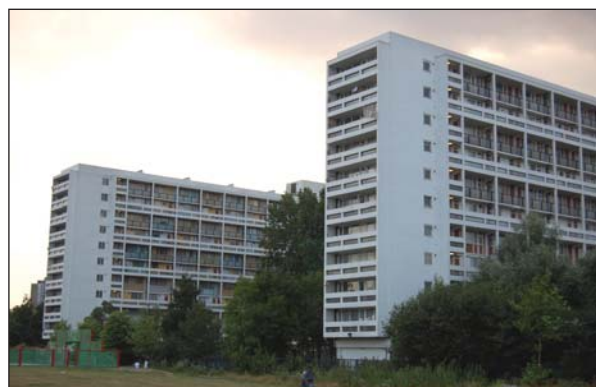
Three nine-storey blocks of flats at Loughborough Estate, Lambeth, have been repaired using concrete repair products from CRA contractor member, **Ronacrete Ltd.**

Following the removal of existing coatings, by low pressure water jetting and grit blasting, Ronabond Fongimousse Plus was applied to kill off mould, fungal growth and algae. The damaged concrete was removed to expose sound concrete and reinforcement steel. Wire brushing was employed to remove rust from exposed steel before it was primed with Ronafix and cement.

Ronafix Mix Design D repair mortar, comprising of cement, sand, Ronafix and water, was applied to reinstate the cut out concrete. Once repairs were complete, a textured slurry coat of Ronafix, cement and sand was applied to the walls and soffits and this was subsequently coated with protective and decorative treatments of Joltec and Zolpacryl.

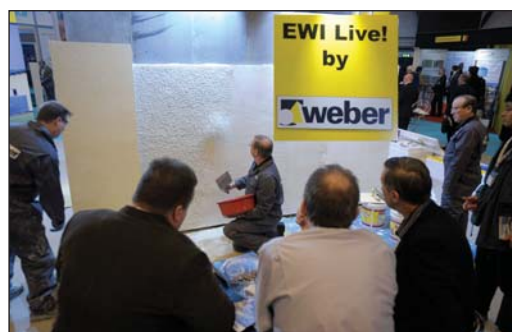
Visitors will experience live demonstrations and can watch the build process of the innovative 'weber.therm XP' External Wall Insulation (EWI) systems, which offer a cost effective method of improving the energy efficiency of existing buildings.

The EWI sample walls will be completed with a variety of high performance finishes including decorative mineral one-coat render and the weber.rend RB brick effect finish that looks as convincing as a real clay brick wall.

weber.therm EWI systems are frequently used in the renovation and rejuvenation of run-down housing stock and damaged concrete substrates. We first require treatment with a Weber concrete repair product. This application will also be demonstrated on a static display illustrating each stage of a concrete repair system by Weber.
